Media Borough - Baltimore Avenue Parking Garage  
S Olive St.  
Media, PA 19063

## February 2019 Condition Assessment

Re: Baltimore Avenue Parking Garage

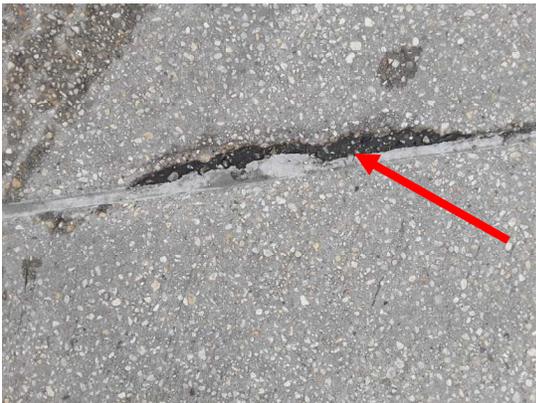
Photo #4: Tee-edge Spalling

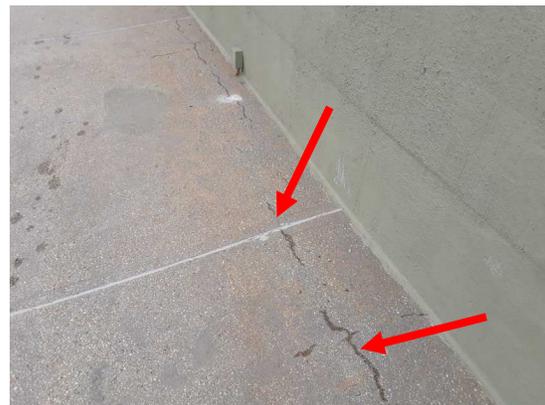
Photo #7: Floor Level Random Cracks

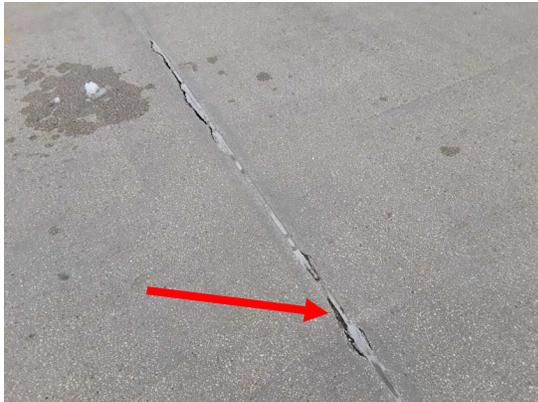
Photo #11: Floor Sealant Failure

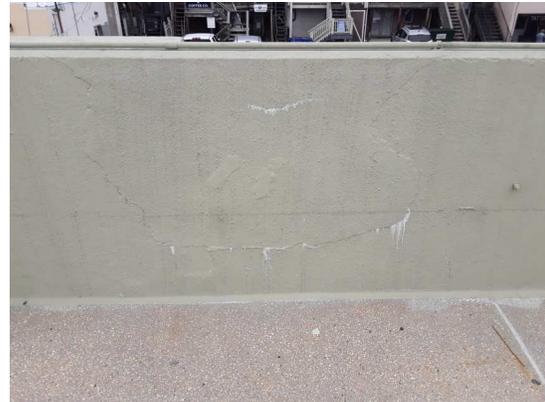
Photo #22: Developing Wall Blowout

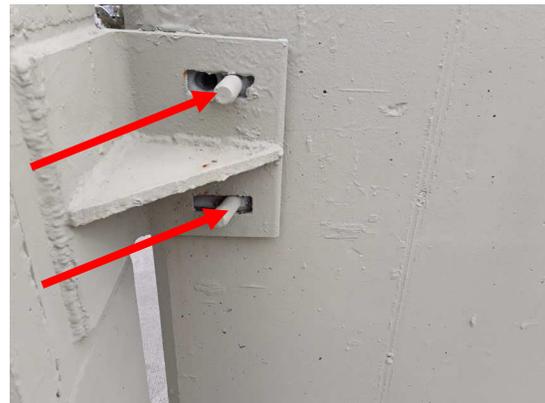
Photo #44: Missing Hardware Lateral Connection

Exposed steel and connections should be cleaned and recoated. All embedded connections should be further inspected during concrete and sealant removal and appropriately cleaned and coated as necessary. The broken double-tee connections at the roof level tee joint along column line six in the south bay and second level along column line four in the middle bay should also be repaired by either reestablishing the connections or supplementing with additional hardware. Additionally, the lateral connection hardware at the roof level east wall missing nuts/washers should be replaced.

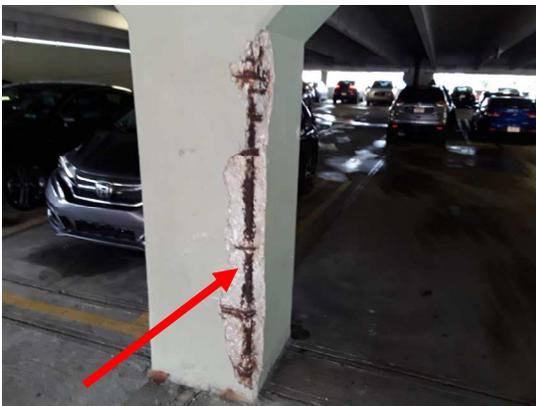
Photo #66: Column Corner Spall

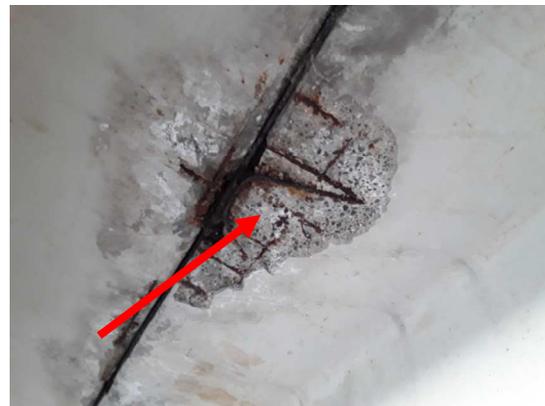
Photo #86: Tee Edge Spalling/Rust Bleeding

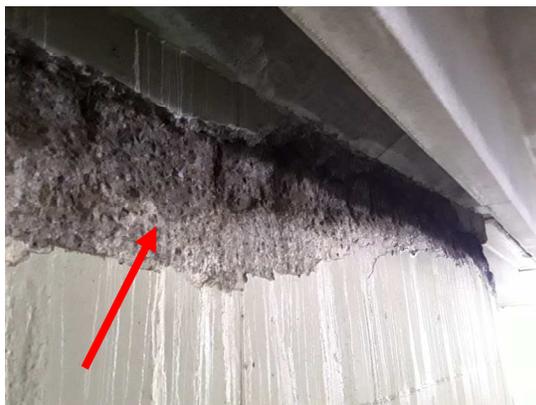
Photo #108: Concrete Delam at Wall Under Ramp

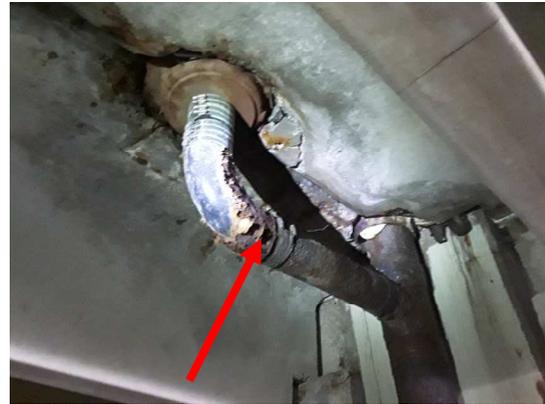
Photo #149: Overhead Drain Body Rust

The drainage system in the garage should be cleaned and coated like the exposed steel and connections. This is primarily required on the second level overhead drain bodies. Additionally, the ten ponding conditions on the roof level and two ponding conditions on the second level should be remediated by installing supplemental drainage or altering grade of the finished floor.

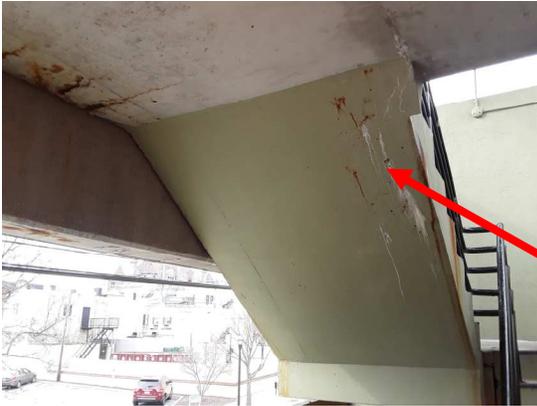
Photo #164: Overhead Concrete Delamination

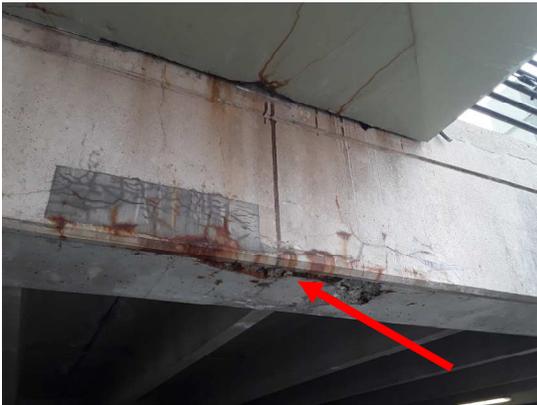
Photo #170: Overhead Beam Spalling

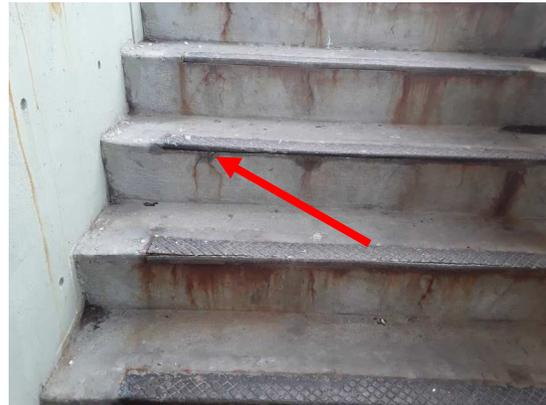
Photo #173: Loosening Stair Treads

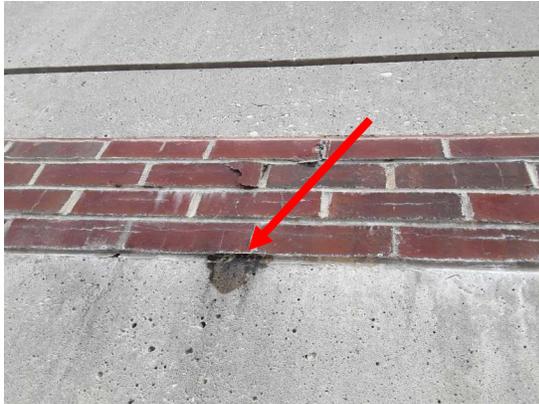
Photo #176: Localized Pointing Deterioration

The exterior façade should be washed with pressurized water and localized masonry pointing re-tucked afterwards.

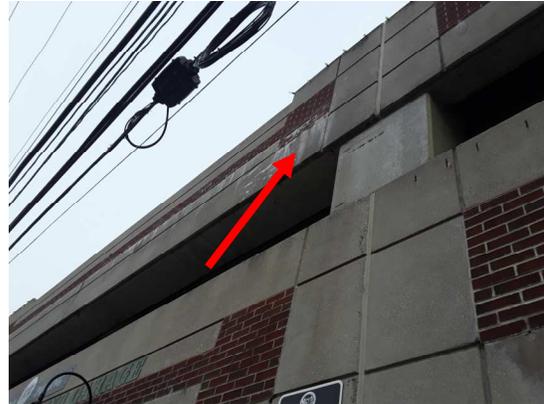
Photo #177: Localized Efflorescence

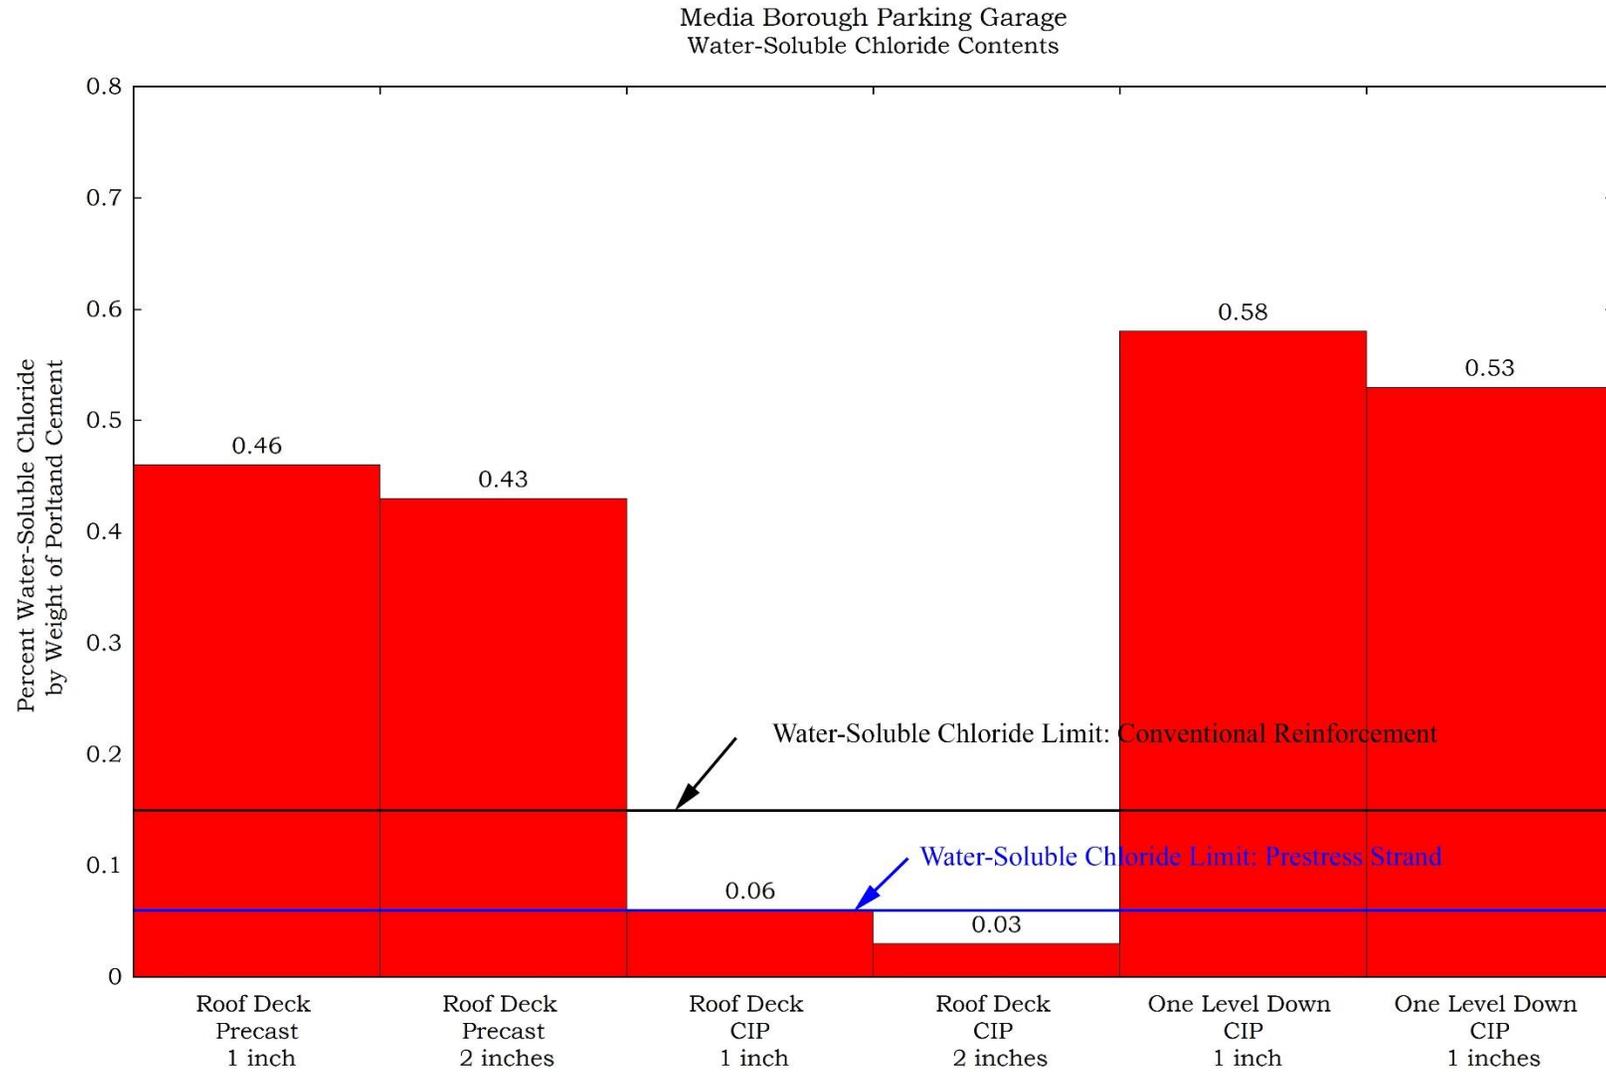
**Figure** – Chart of water-soluble chloride contents for the samples assuming unit weights and portland cement contents of the precast and cast-in-place concretes.

The chloride profiles demonstrate that the concrete slabs have been exposed to external chlorides (chloride-based deicing agents) from the top surface. Except in the CIP samples from the Roof Deck, water-soluble chloride contents at all sample locations (Precast on the Roof Deck and CIP, One Level Down) exceed the threshold levels for initiation of corrosion in new concrete established for both prestress strand and conventional reinforcement to depths of at least 2 inches. The results of the analyses are summarized in the Table and Figure.
