Media Borough - Baltimore Avenue Parking Garage  
S Olive St.  
Media, PA 19063

## February 2019 Condition Assessment

Re: Baltimore Avenue Parking Garage

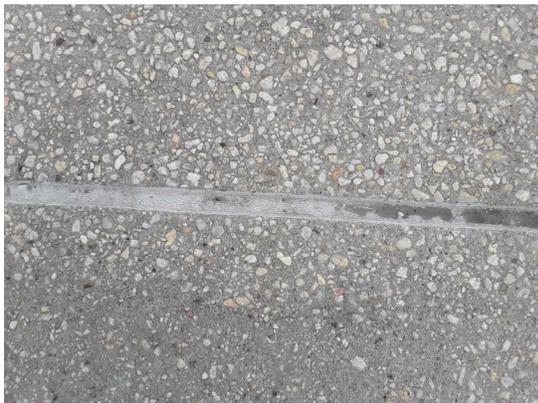
Photo #31: Scaling Concrete

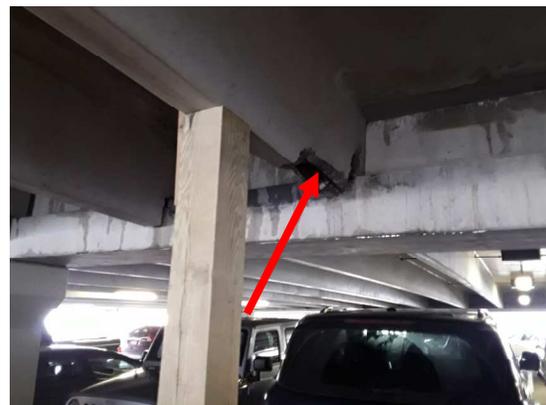
Photo #131: Shored Tee Stem

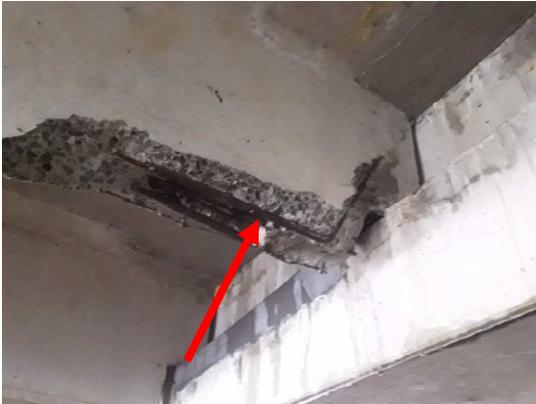
Photo #132: Close-up Shored Tee Stem

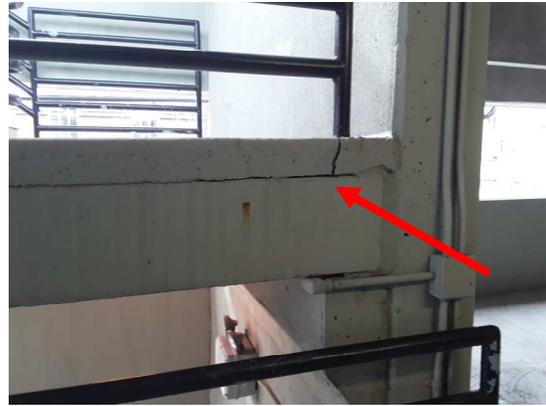
Photo #166: Landing Concrete Delamination

Lastly, the stair towers should have localized repairs conducted in the form of: floor level and overhead concrete repairs, perimeter floor level sealant replacement, localized re-painting of walls, replacement of loosening stair treads, and application of a corrosion-inhibiting treatment to the exposed concrete surfaces.

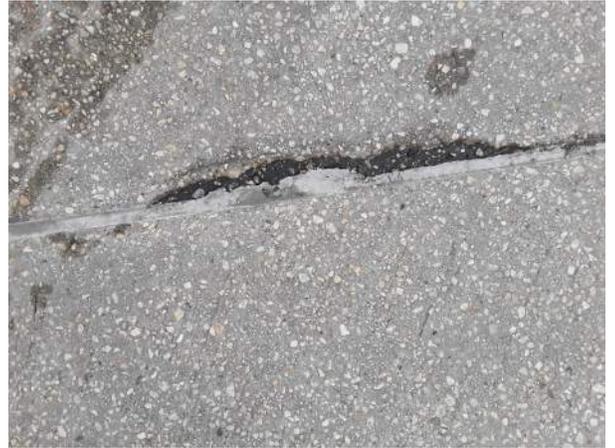
4.

Photo #4: Tee-edge Spalling

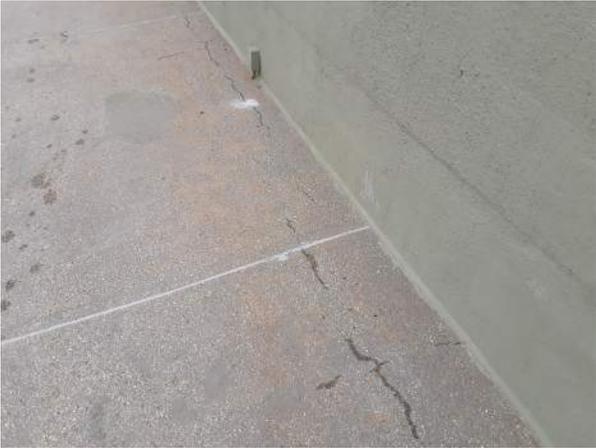
7.

Photo #7: Floor Level Random Cracks

Concrete repairs within the garage structure should consist of routing/sealing cracks and removal/replacement of spalled/delaminated concrete with a structural grade repair material or epoxy and appropriate application of a corrosion inhibiting treatment and sealer over the entire finished floor of the roof and second level. Most of this work is focused towards the floor level concrete on the roof and second level and vertical/overhead concrete on the second level. In several cases on the second level, shoring may be required to temporarily stabilize precast members while repairs are implemented. Such cases include select double-tee stems and overhead girder ledges.

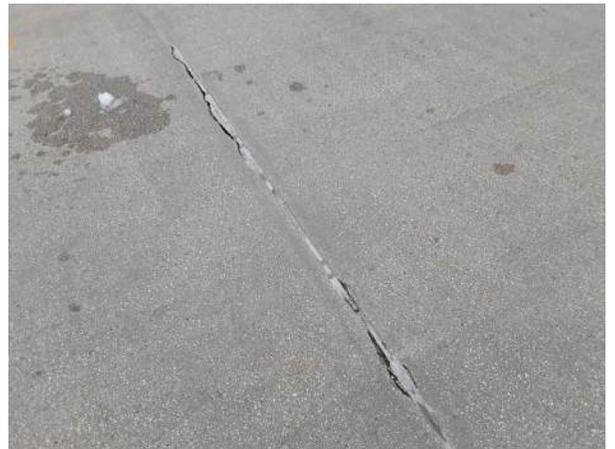
11.

Photo #11: Floor Sealant Failure

Waterproofing repairs/replacement should consist of removal of failed material and replacement with a two-part, traffic grade urethane sealant for the floor level joints. The roof level should have all floor level sealants replaced and localized repairs conducted on the second level. The architectural joints on the interior of the roof level should also be replaced, but traffic grade is not required since these sealants are a vertical application.

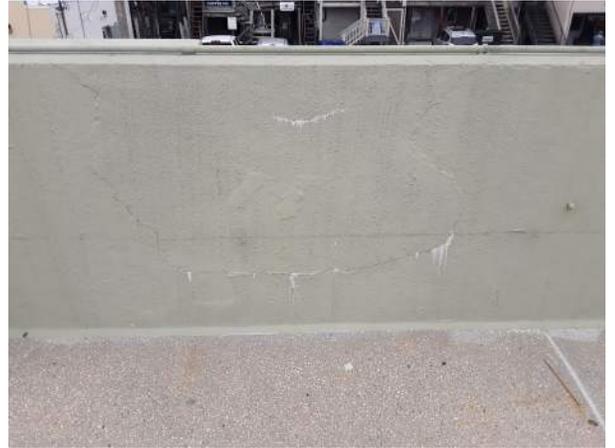
22.

Photo #22: Developing Wall Blowout
